Inspection Report

Property Address:
123 Main Street
Charlotte, NC 28269

Lake Norman Home Inspections, LLC

Date: 2/19/2010	Time: 11:00 AM	Report ID: 507
Property: 123 Main Street Charlotte, NC 28269	Customer: John Smith	Real Estate Professional: Darrell Mullins Wilkinson and Associates Real Estate

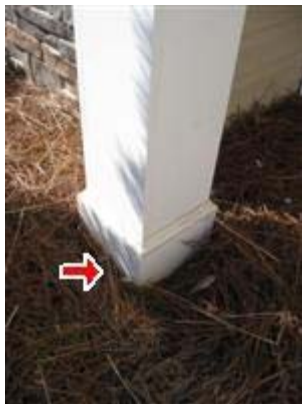
1.6 Picture 1

1.6 The wood columns to the right and left of the front door are in contact with the ground. Wood columns in direct contact with the ground will deteriorate over time. Have a general contractor assess and correct.

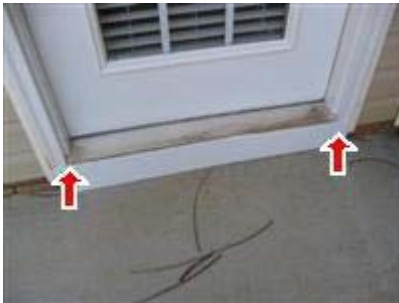
2.8 Picture 1

2.8 There needs to be caulk applied where the bottom right and left sides of the rear door trim meets the threshold (Picture 1 and Picture 2). There needs to be caulk applied where the bottom right and left sides of the front door trim meets the threshold.

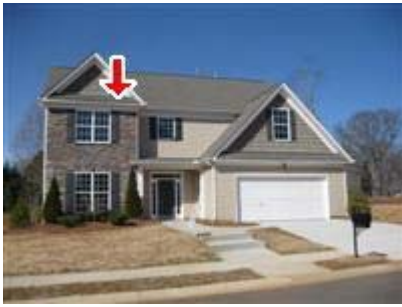
4.0 Picture 1

4.0 There are two damaged shingles on the front of the house below the left most gable (Picture 1). There is a lifted shingle at the rear left corner of the roof (Picture 2). The shingles on the front right side of the roof are drooping over the edge of the roof (Picture 3). Shingles should extend 1 and 1/2 inches over the edge of the roof. These shingles extend approximately 2 1/2 inches over the edge. Have a roofer assess and correct as necessary.

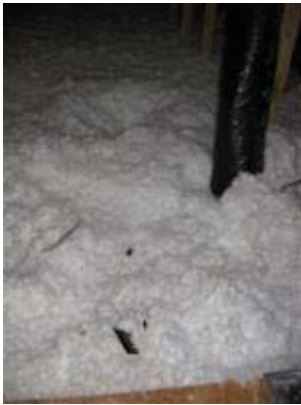
4.12 Picture 1

4.12 The attic insulation is matted and shallow in several places to the left of the attic stairs. This significantly reduces its insulating value. Have an insulation specialist replace it as necessary.

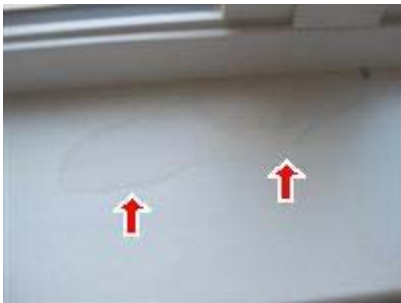
5.4.E Picture 1

5.4.E There is a water stain on the center of the threshold beneath the rear windows. The stain measured dry at the time of inspection. Monitor and if necessary repair.

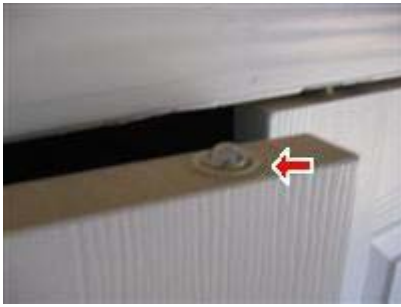
5.3.H Picture 1

5.3.H The left closet door won't latch. Adjust and repair as necessary to return to proper operation.

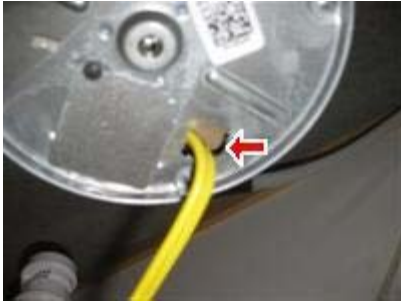
7.17 Picture 1

7.17 The stress relief clamp is missing from the point where the electrical wiring connects to the bottom of the garbage disposal. The stress relief clamp prevents the electrical line from being pulled loose. A stress relief clamp should be

installed.

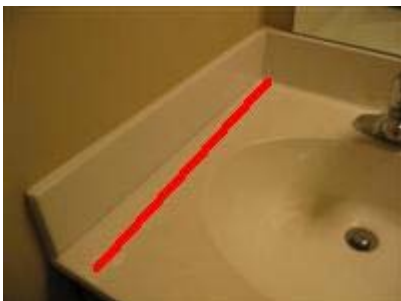
8.15.A Picture 1

8.15.A There needs to be caulk applied, where the second level hallway bathroom sink backsplash meets the left side of the countertop, to prevent water intrusion.

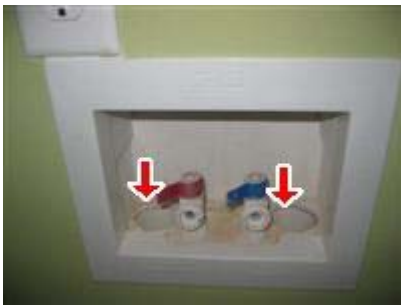
10.3 Picture 1

10.3 I could smell waste by the washer drain line in the laundry room. This could be caused by a drain line trap that is dry due to the house being vacant, or there isn't a trap. Have a licensed plumber ensure that there is a trap for the washer drain line.

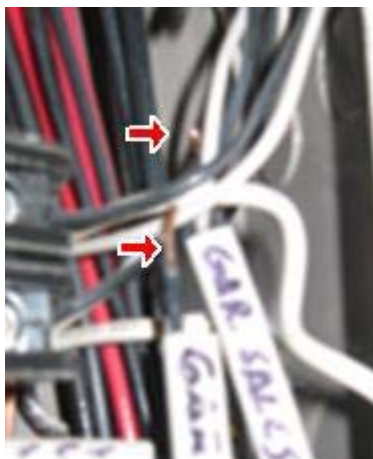
11.6 Picture 1

11.6 There are two wires in the distribution box that aren't terminated. Wires that aren't terminated can come in contact with electrically active points inside the panel and create a safety hazard. Have the wires terminated with wire nuts. The panel is located in the garage.

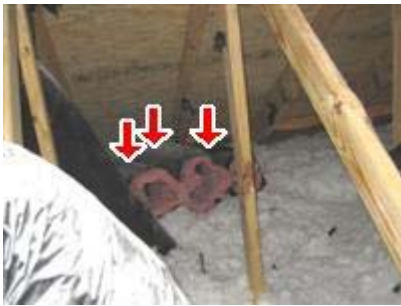
12.3 Picture 1

12.3 There isn't any air flowing from the supply register, on the left side of the foyer, while the heat is operated. There are several ducts in the attic, above this area, that aren't connected to anything (Picture 1). Have a licensed HVAC professional assess and correct.

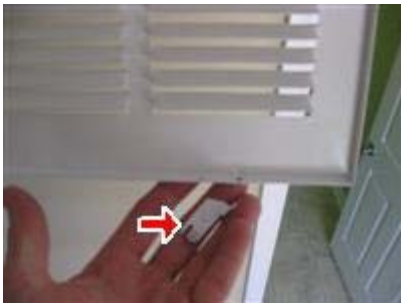
12.12 Picture 1

12.12 The left clip that holds the return grate (in the kitchen) in place isn't attached to the grate. Replace and repair as necessary.

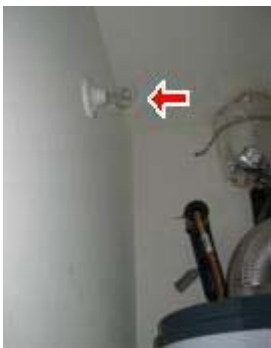
14.1 Picture 1

14.1 The light by the water heater (in garage) isn't functioning. Replace bulb and make sure there is a switch to turn the light on.
